# **ROD MUNRO LIMITED**

## **EXAMPLE BUILDING CONDITION SURVEY REPORT**

**21<sup>st</sup> May 2018**

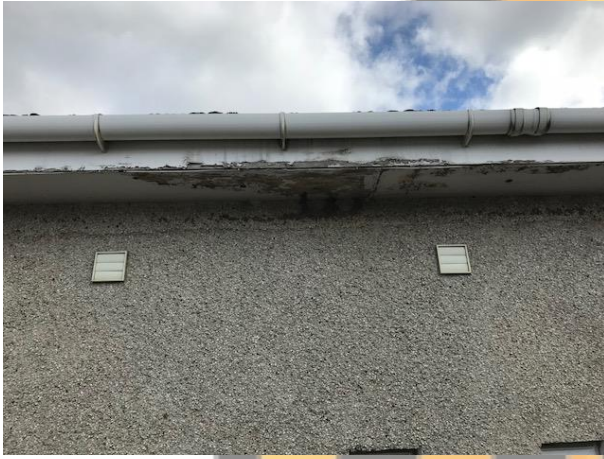
The external facias and soffit are of timber construction, there is evidence of water damage and the paintwork is in a poor condition and flaking in several locations.

Timber Soffit & Facia – Damaged Paintwork

We recommend the external timberwork, soffit and fascia boards are prepared and properly painted to prevent timber decay.

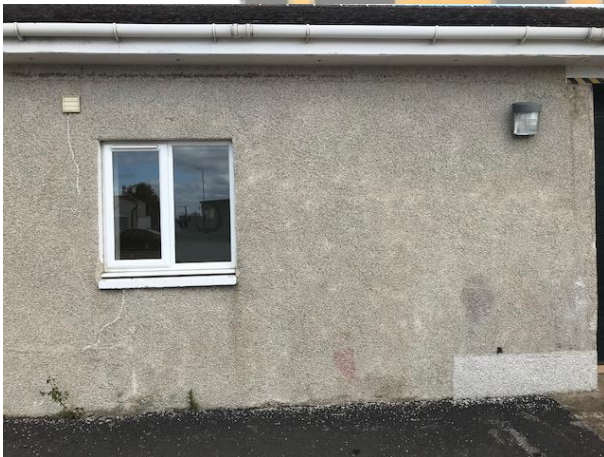
Façade & Kitchen Window

The external render has been repaired in many locations where the building has been adapted, the repairs are quite obvious.

Render repair to bottom right corner, crack repairs below window and vent outlet

We recommend the external render repairs are monitored and the repairs be repeated should there be a risk of rain water penetrating into the buildings wall construction.

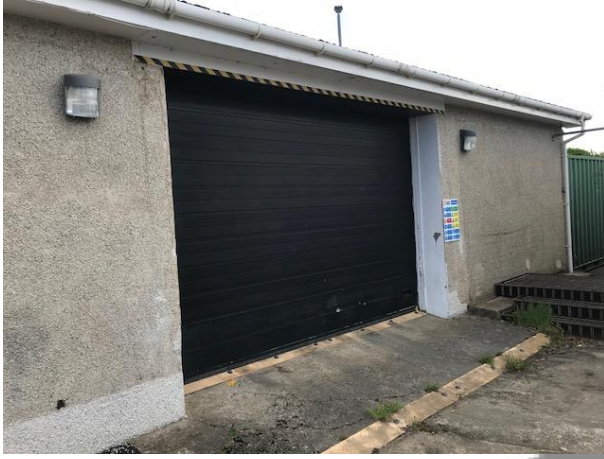
Façade & Workshop Entrance

Render repair to workshop door surround

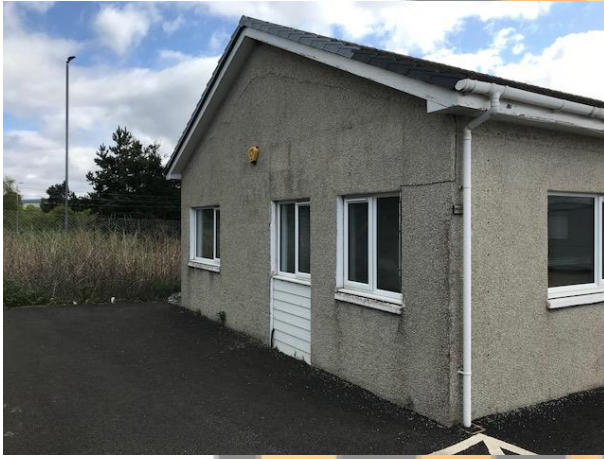
End Elevation

Render repair to underside of soffit

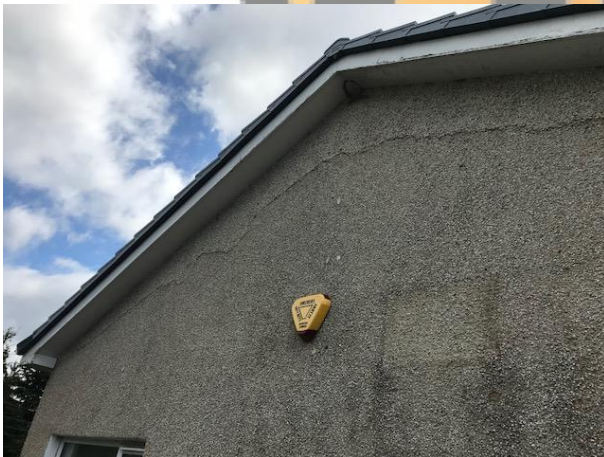
End Elevation

Render repair to underside of soffit

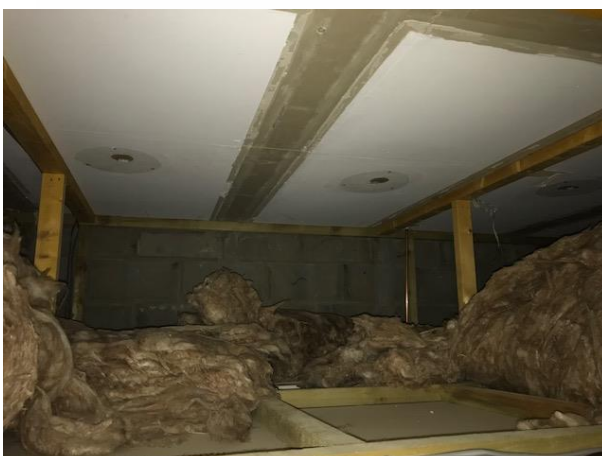
Roof Space – Double Ceiling

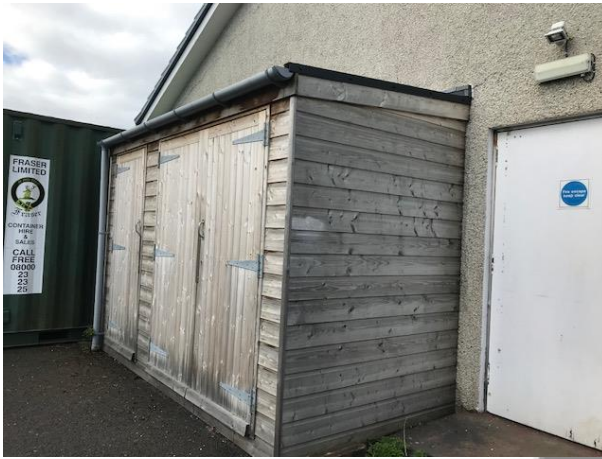
Compressor Store - Locked

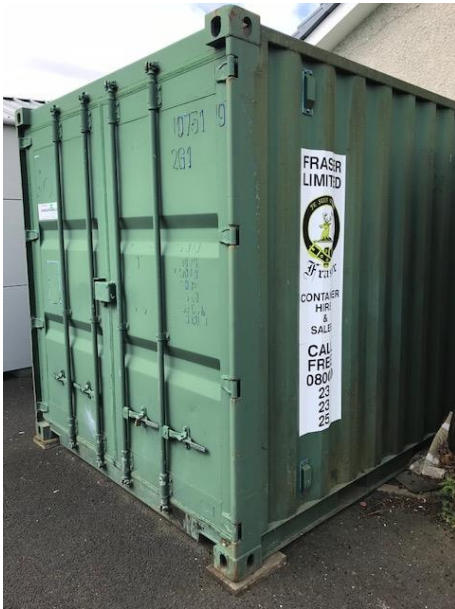
Container Store - Locked

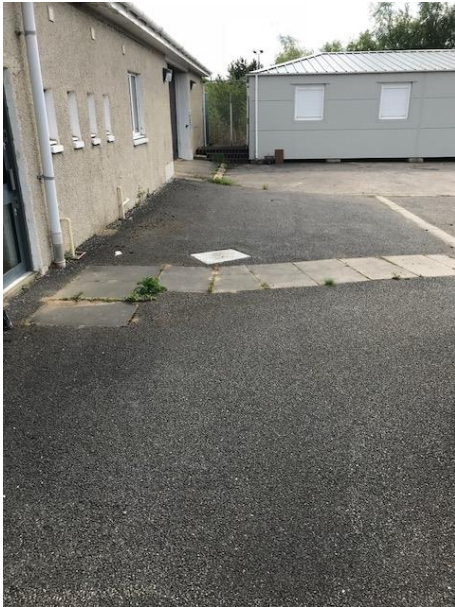
External Hardstanding – Vegetation to Slab Path

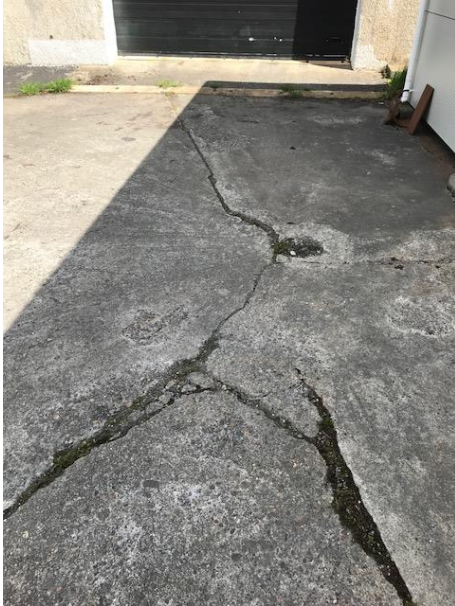
The external concrete hard standings are original to the building with surface damage and structural cracking.

External Hardstanding – Cracked Concrete

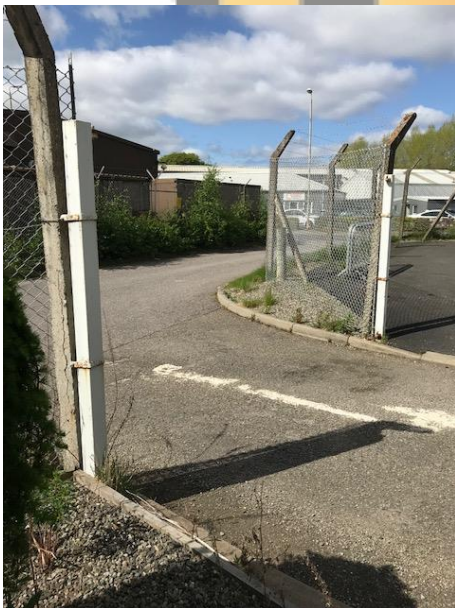
External Hardstanding – Vehicle Gateway

The security fencing is 2m high chain link with three rows of barb wire supported by both metal and concrete cranked posts, the fence appears to be in good condition. There are a vehicle and pedestrian gateway within the security fence but we note the gates are absent.
